# Field testing of LineSmarts

By Carl Rathbone of LineSmarts Ltd 10/05/15

This report details and discusses two field tests, which compared LineSmarts tension results against dynamometer tension measurements.

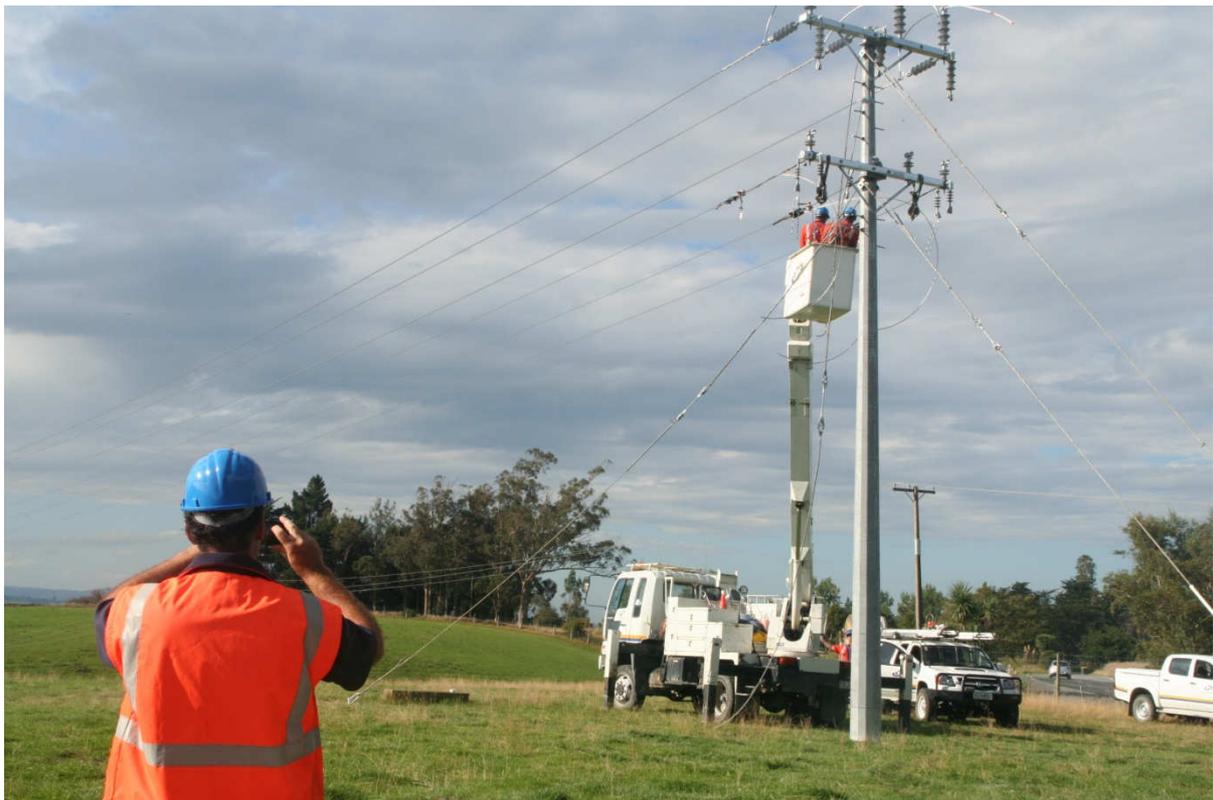
Figure 1: LineSmarts measurement being made

On arrival at site the top circuit had been strung and terminated. The second circuit had been strung and was sitting in come-along clamps at approximately the correct tension. All three phases had dynamometers attached. Two LineSmarts measurements were recorded before the conductors were adjusted to the target tension of 190kg. The penultimate and

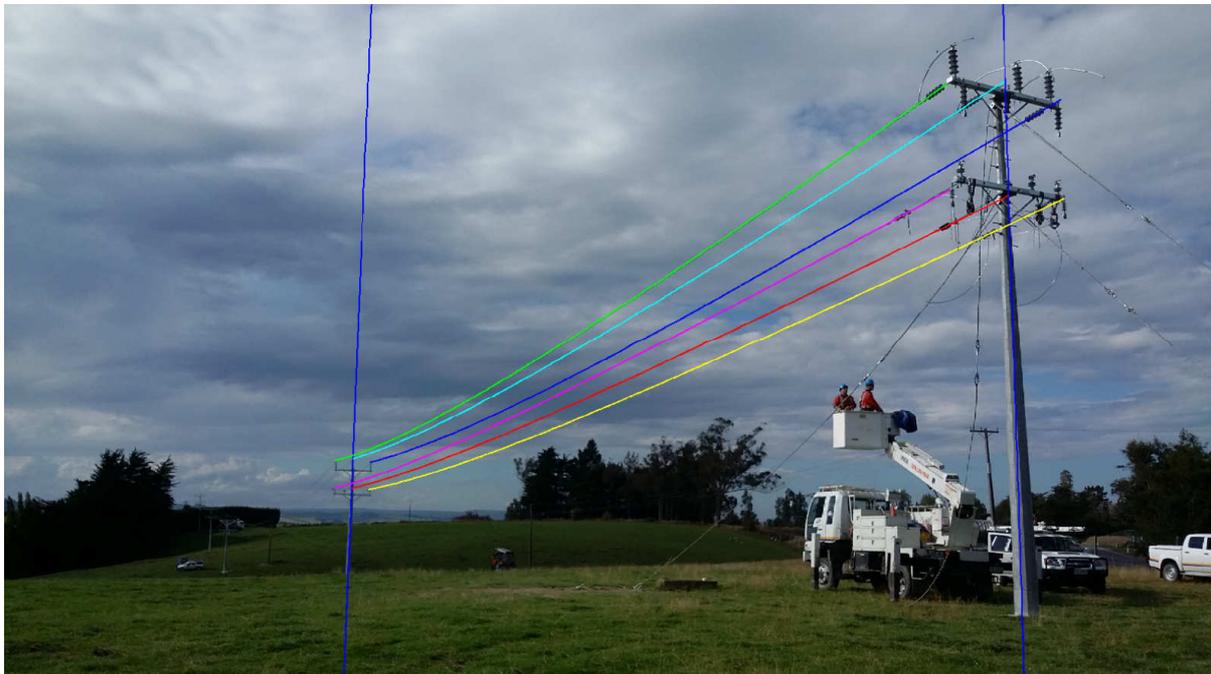
Figure 2: Surveyed conductor positions captured by LineSmarts

Another issue with the results is that both devices show a discrepancy between physical and LineSmarts tension measurements for the middle phase. This is not unexpected. LineSmarts does not currently allow individual definition of attachment offsets for the structures at either

end. In the spans measured, the attachment point switched from one side of the pole on the first structure, to the other on the second pole. Thus a correct offset could not be entered resulting in an error being introduced. The amount of error could be minimised by making measurements positioned perpendicular to the span centre.

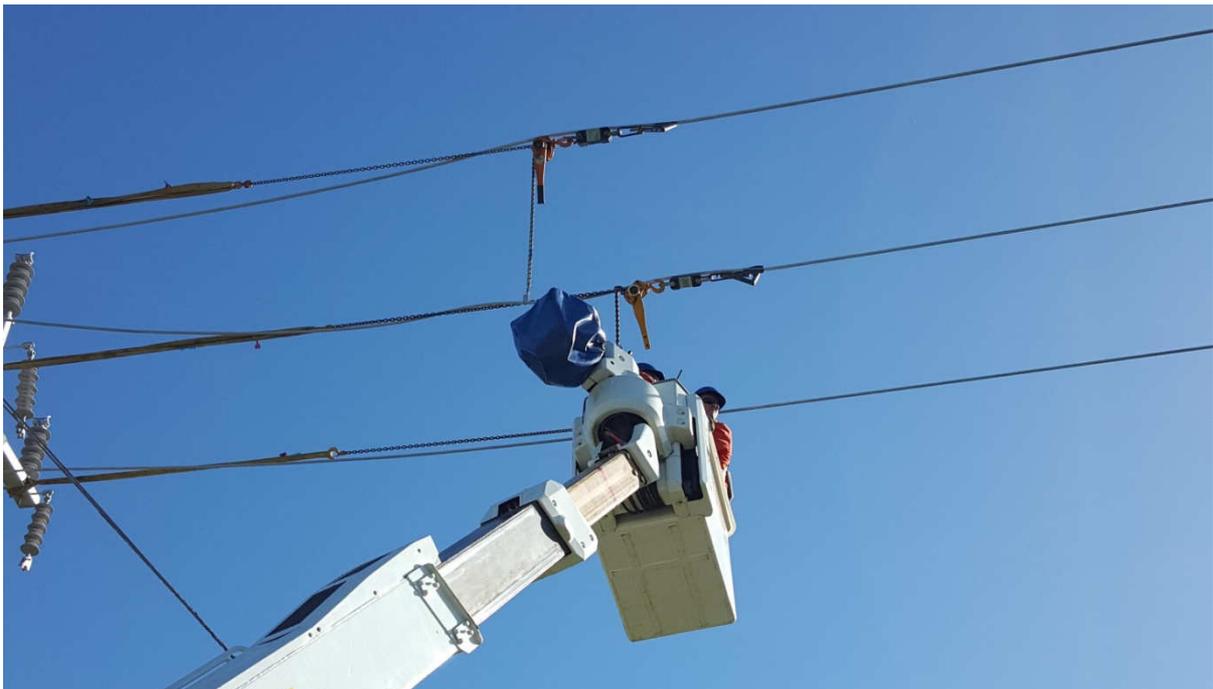
Figure 3: Dynamometers set up to measure tension

Dynamometers were fitted to 2 phases, the left and centre phases. The third phase was sagged by eye to match the other two. Measurements were taken from 4 different locations and at various stages during the process of tensioning up and terminating the conductors. The LineSmarts measurements are shown in Table 2, arranged in the order they were collected. The positions from which the measurements were taken are shown in Figure 5, with examples of the images given in Figure 6. The same set of range measurements were used at each site.

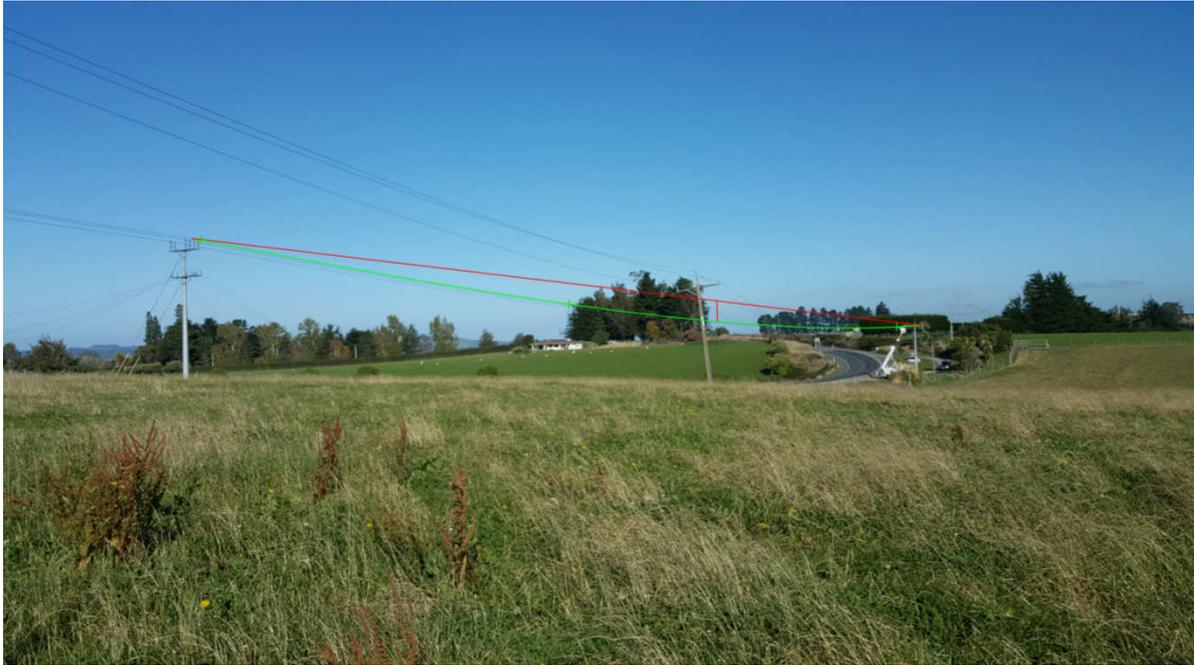
Figure 4: Right hand phase tension measurement on 16/04/15

Probably the most significant factor affecting the precision of the measurements on this occasion was the visibility of the conductor. Identifying the position of the conductor was made difficult by the fairly long span, that half the span had a dark background of trees and because during the stringing process it is difficult to reliably estimate the attachment point. Also it appears that there might be a bug with LineSmarts that means it does not always achieve the optimal focus. Experiments taking photos on the S6 using both LineSmarts and the native camera app indicate that the photos taken using the camera app had much better focus. The significantly better focus would make it far easier to select detail in the image. The issue has not previously been so apparent because earlier testing has used smaller cameras, which are less sensitive to focus accuracy.

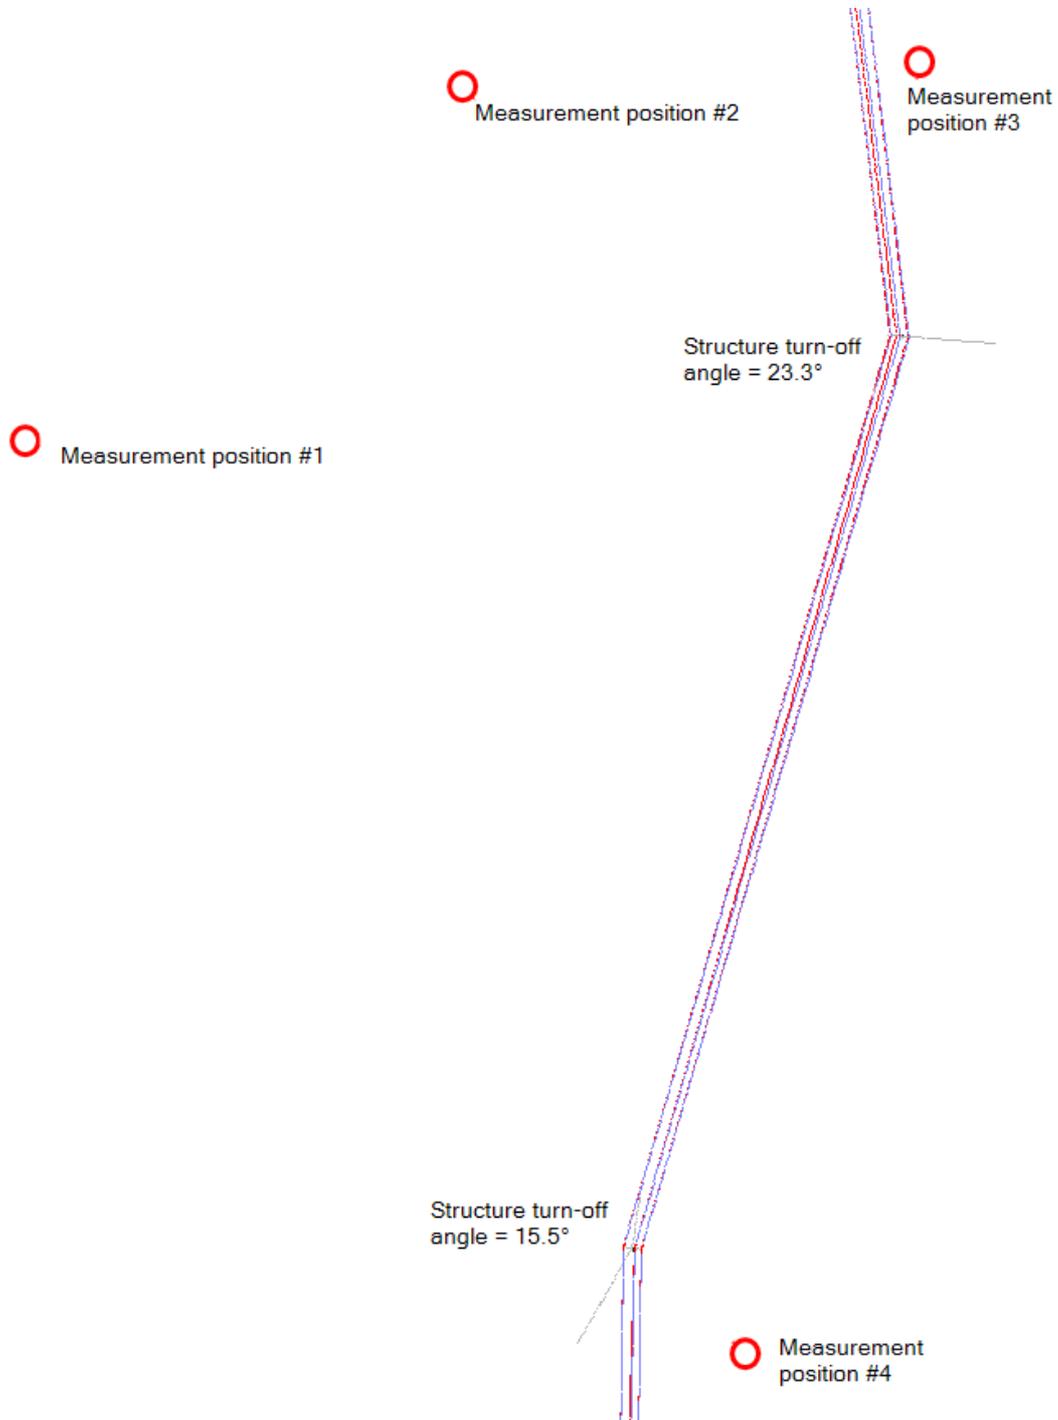
Figure 5: Measurement locations

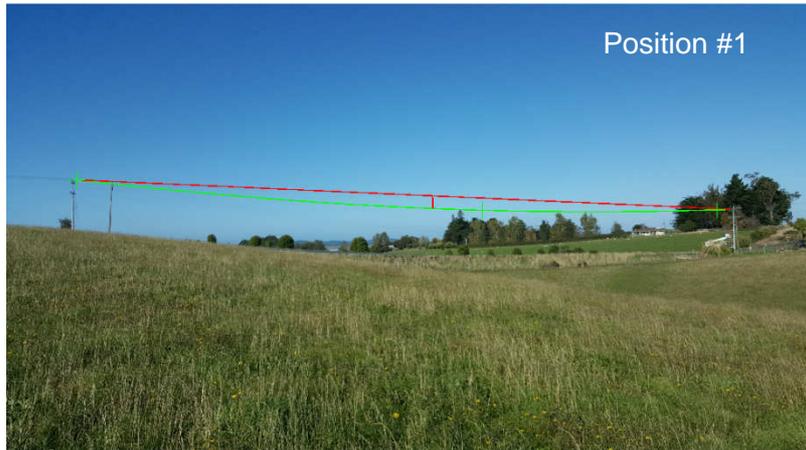
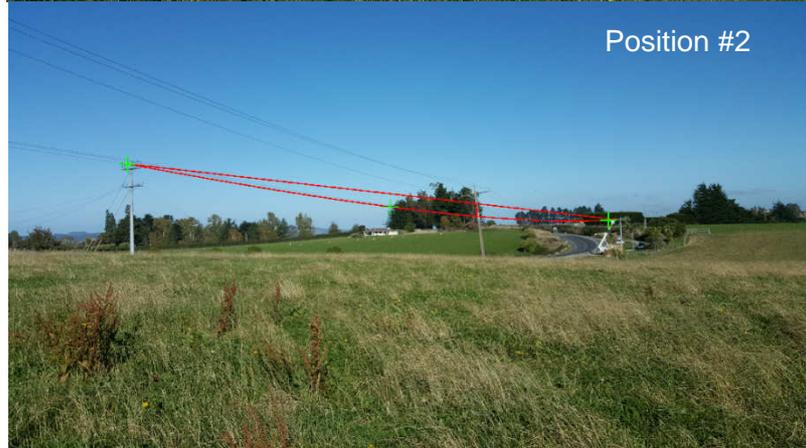
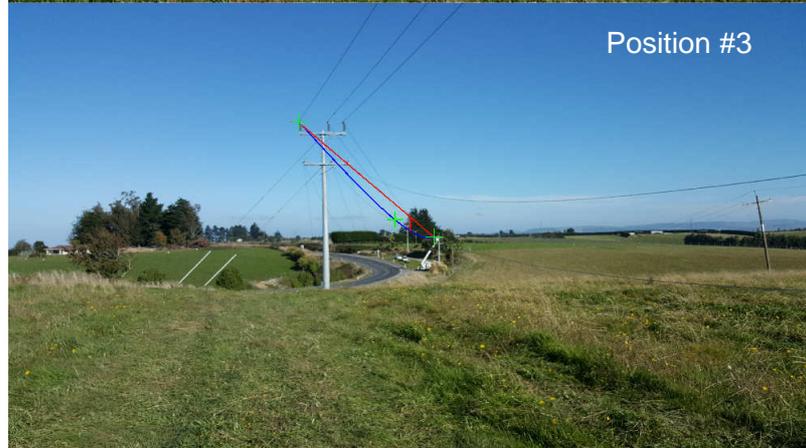
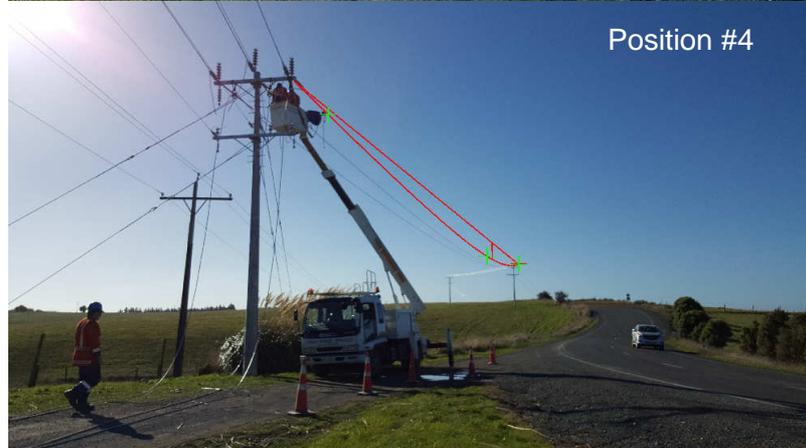
Figure 6: Images from 16/04/15 using the Samsung Galaxy Tab Pro 8.4 tablet
